⑨ BUREAU OF SHIPS GROUP
TECHNICAL INSPECTION REPORT

⑥ OPERATION CROSSROADS
U.S.S. SARATOGA (CV3)

TEST ABLE

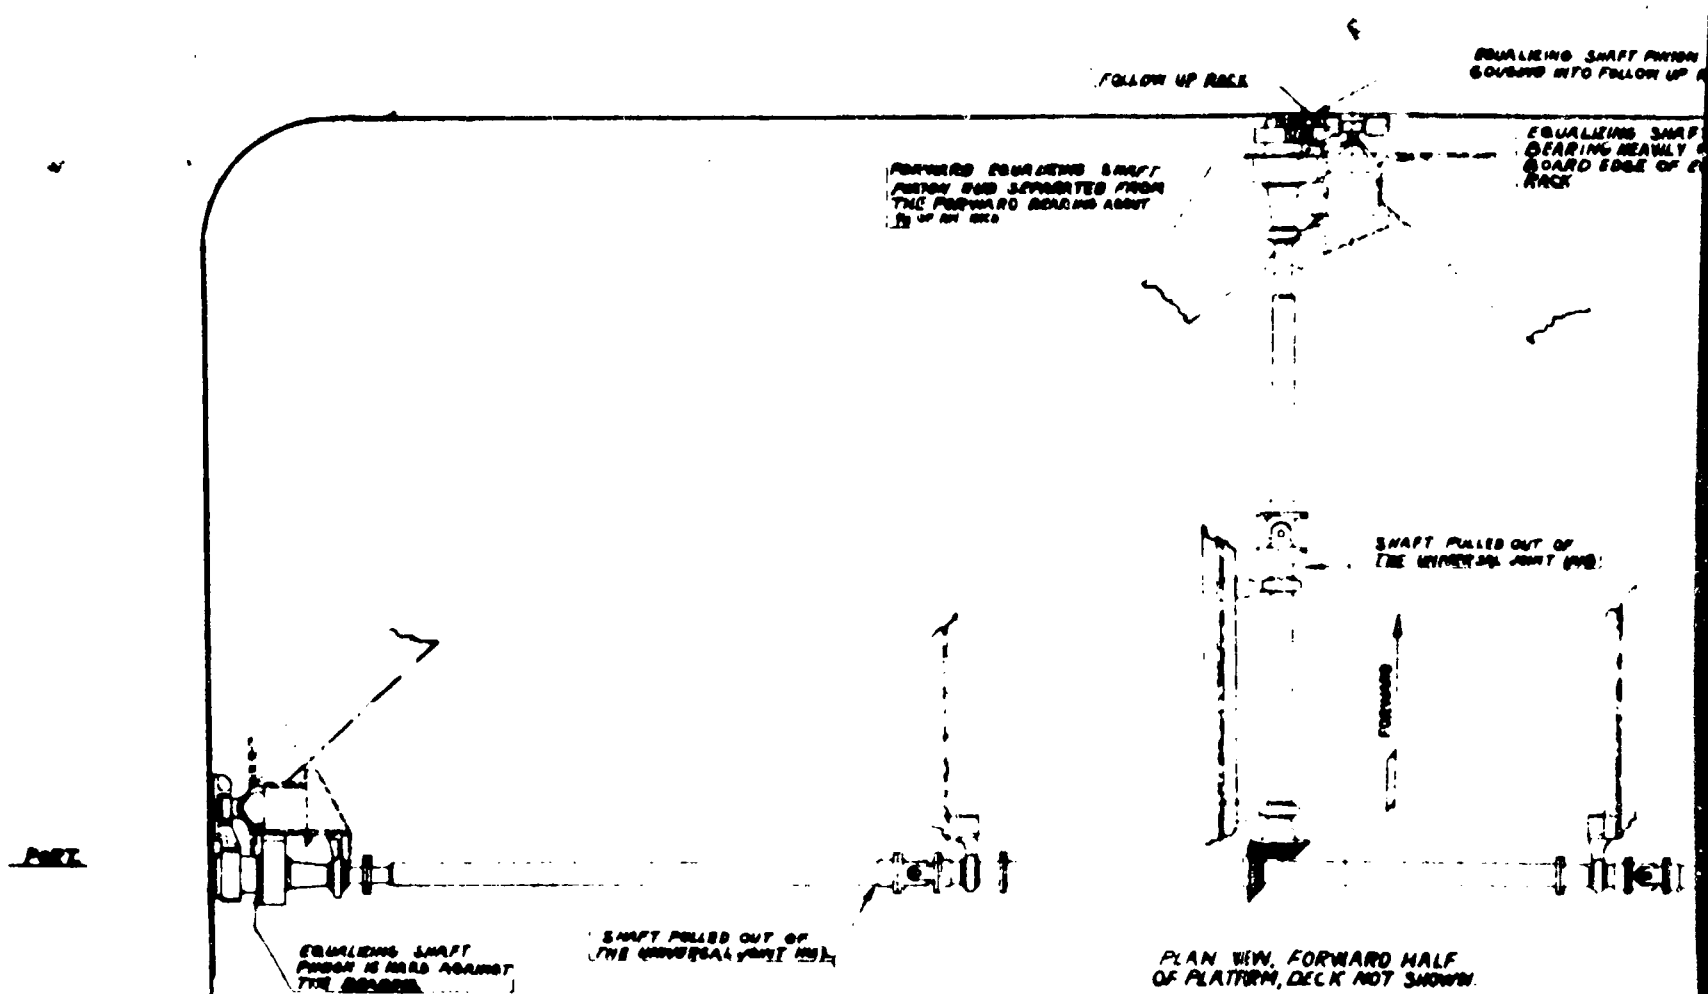
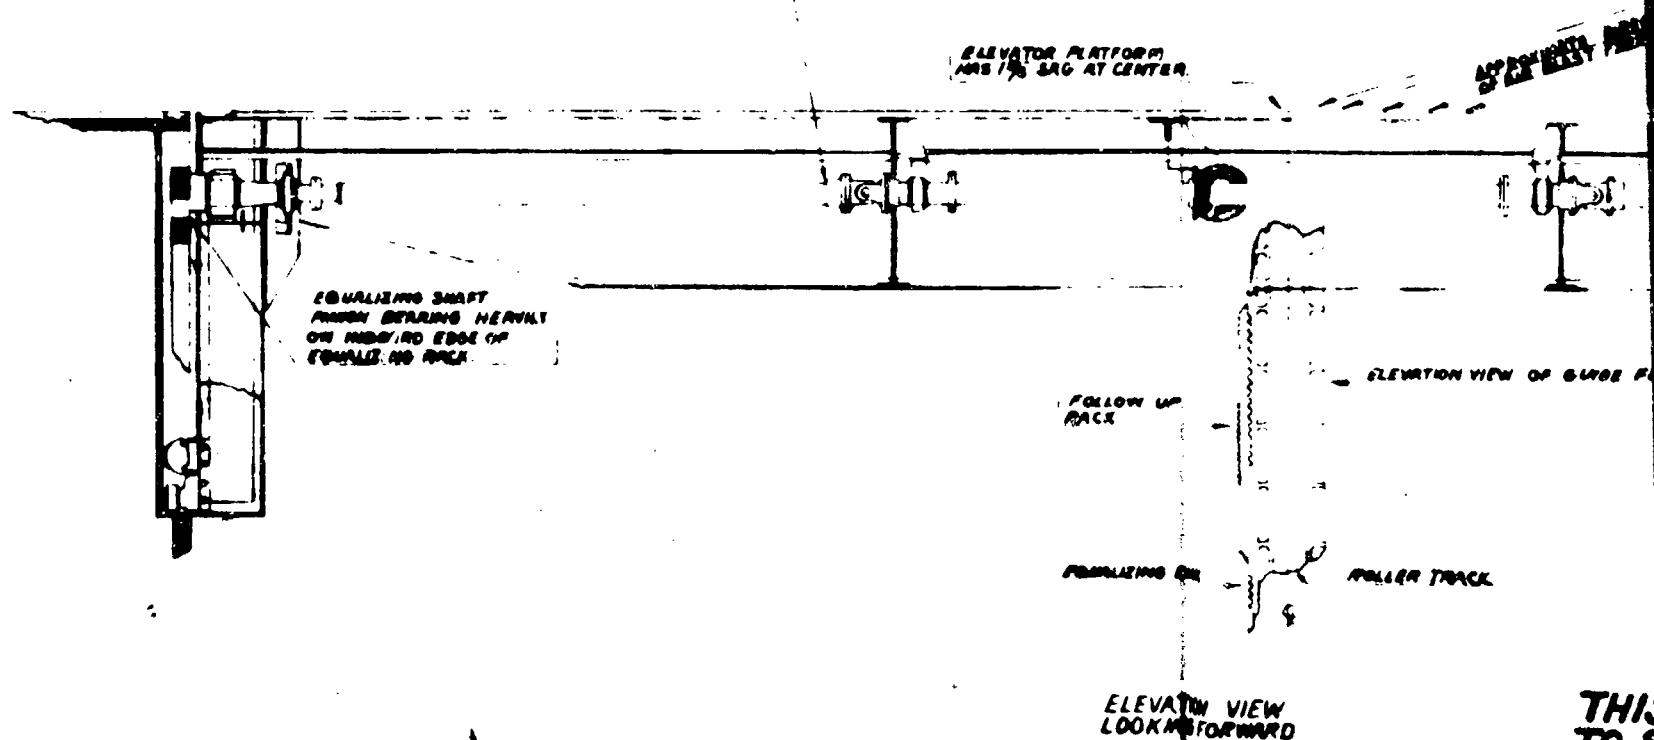
4. The position of the pinions and shafts indicates that the elevator platform sprung downward considerably near its center, pushing the platform downward and somewhat to port (See drawing, page 32). There is some structural damage to the elevator platform not covered in detail here (See Section I - Hull).

EQUALIZING SHAFT PINION
GOURING INTO FOLLOW UP RACK.

EQUALIZING SHAFT PINION
BEARING HEAVILY ON IN-
BOARD EDGE OF EQUALIZING
RACK

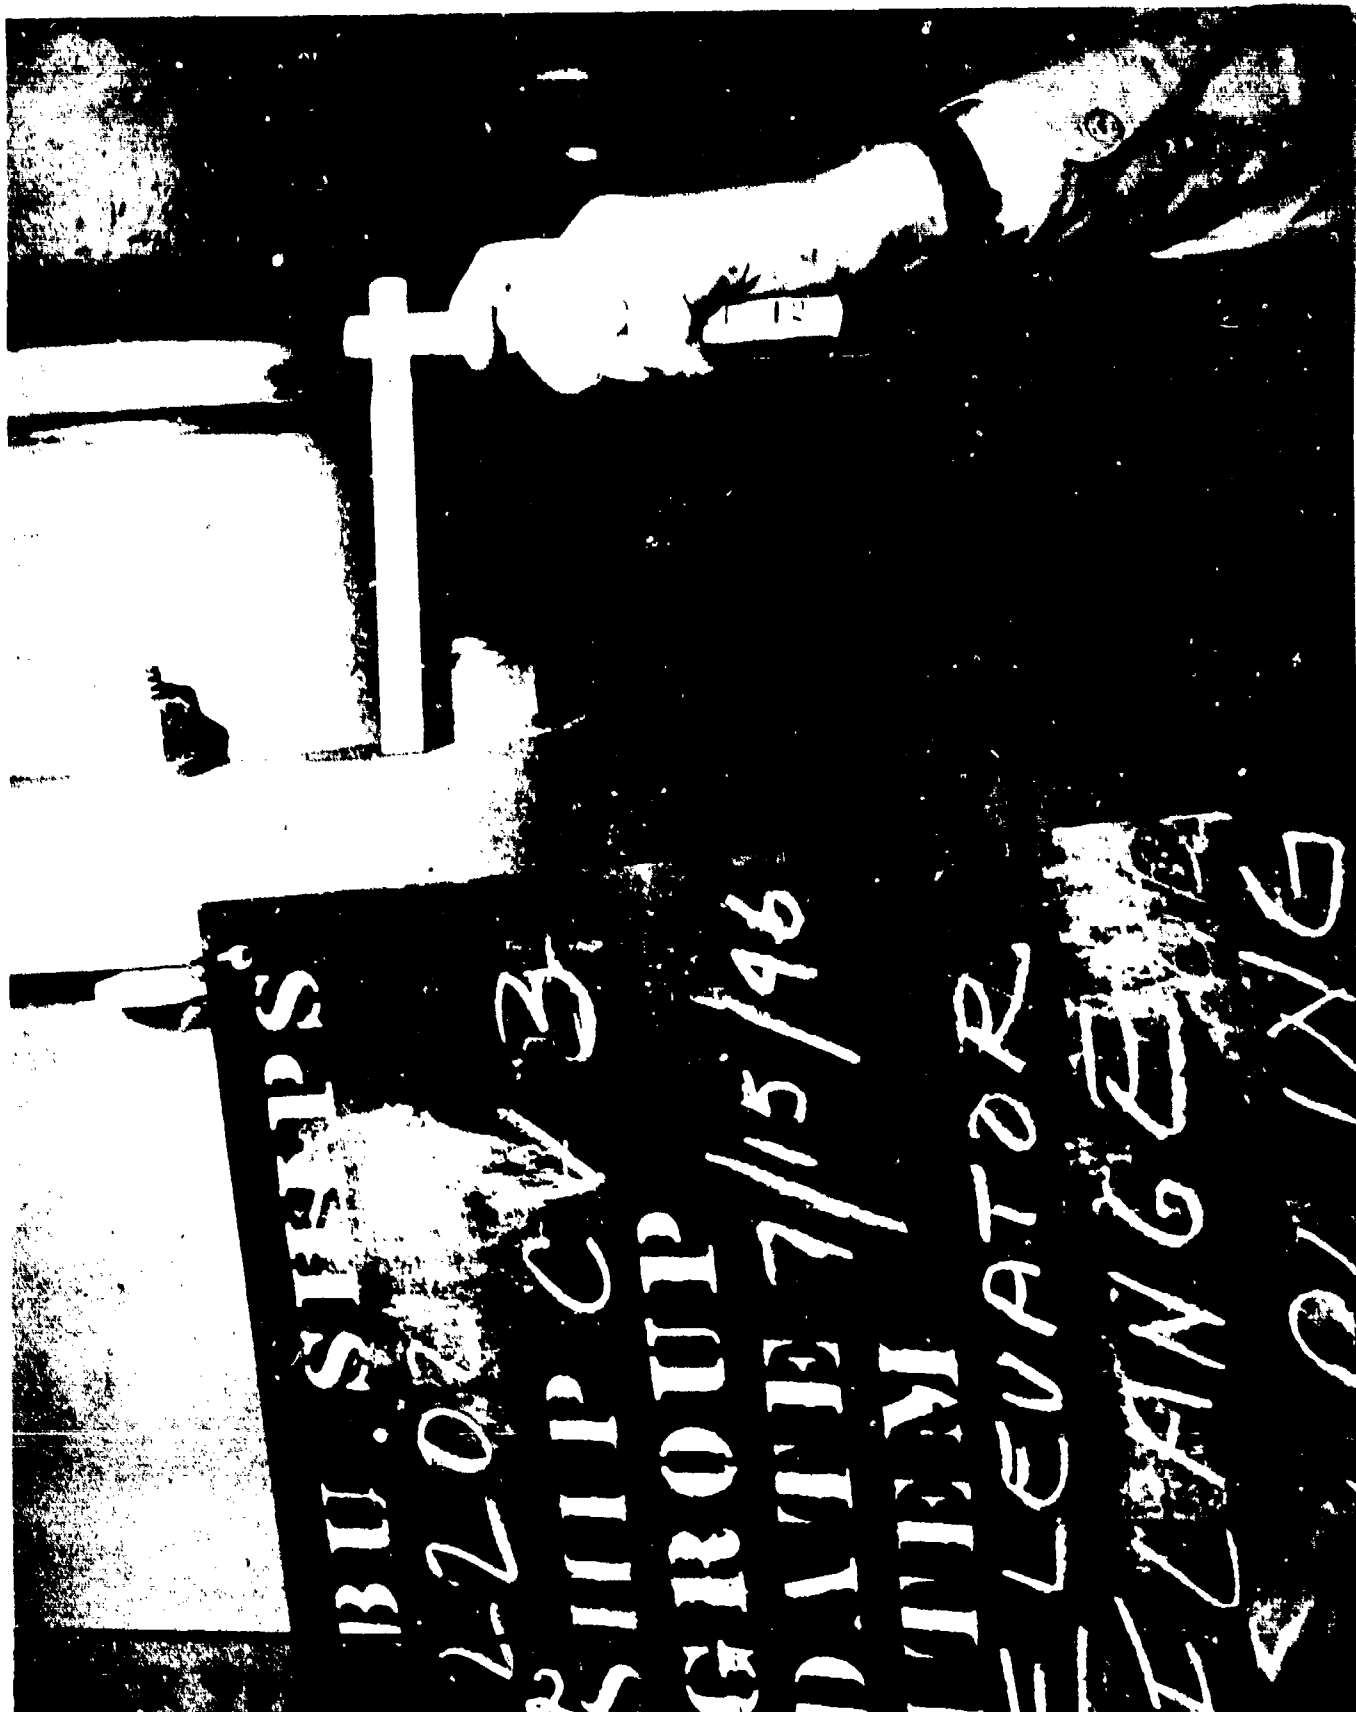
AA-CR-90-2202-2. View of forward elevator showing displacement of flange coupling on equalizing shaft.
